Methods of grout quality measurement in borehole exchangers for heat pumps and their rehabilitation

Petr Nakládal^{1*}, Martin Procházka², Viktor Goliáš¹ and Jaromíra Hrdá³

Keywords: Geothermal energy, Heat pump, Carottage, Borehole repair

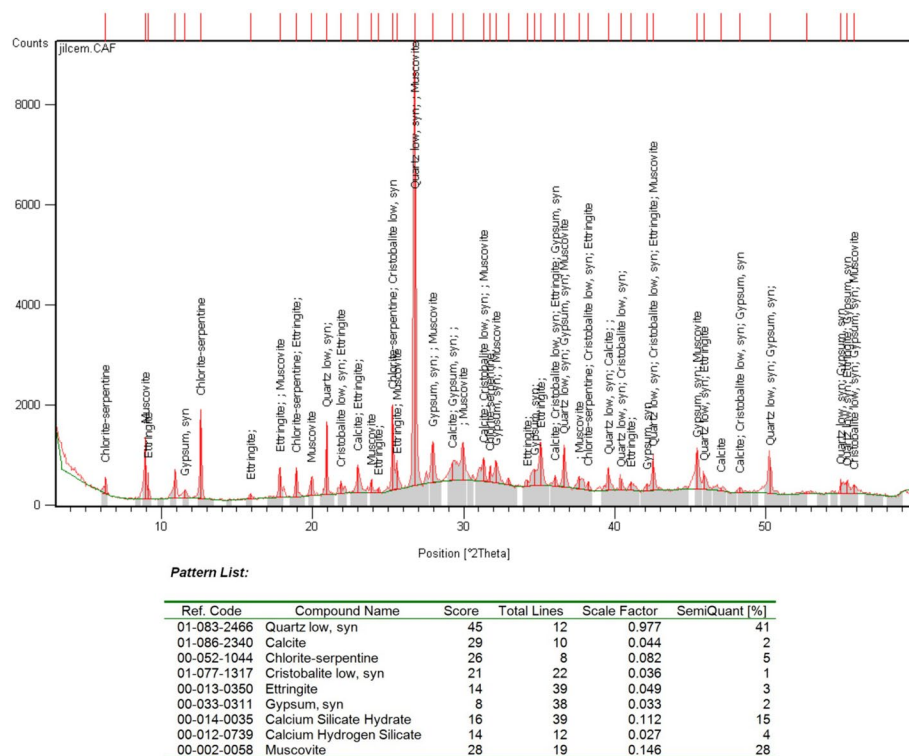
Fig. 3 Results of the X-ray powder diffraction analysis of the hardened, commercially produced grouting mixture

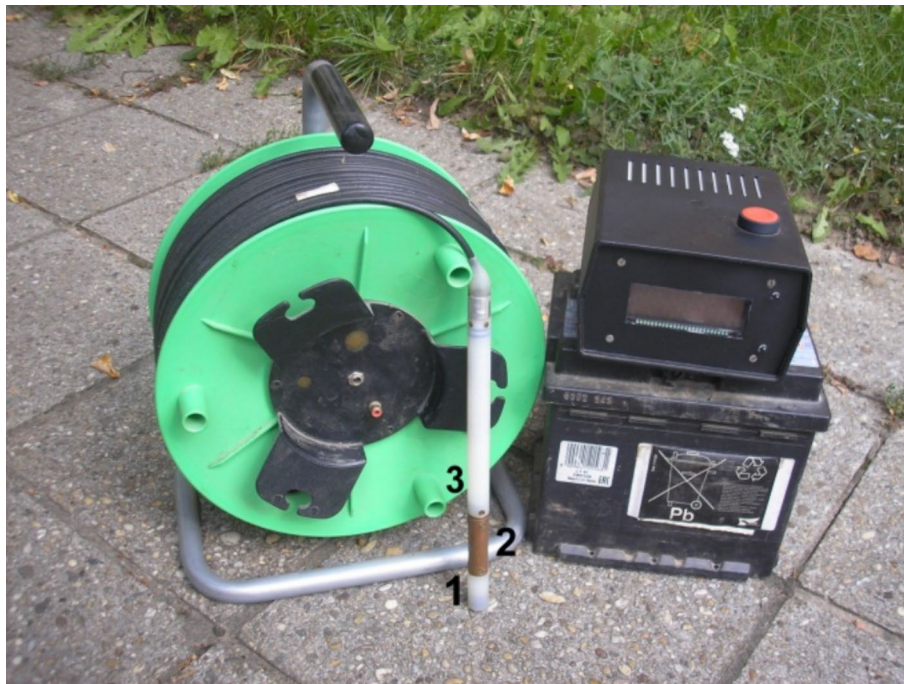
Fig. 4 Small diameter probe on GGL. 1: emitter; 2: shielding; 3: detector

The development of a small-diameter probe with a small range requires the verification of a different measurement structure than is commonly used. A piece of pitchblende from the Faculty of Science of Charles University collections was used as the first experimental emitter. Based on these successful tests, in June 2015, the Aquatest Drill logging Department (now Geotechnika) ordered the production of one probe for measuring the grouting of ground heat pump exchangers. The Aquatest/Geotechnika staff supplied special gamma shielding material and purchased a 137 cesium gamma radiation (300 MBq) source to produce the probe. The source of the appropriate intensity was selected based on the experiments on the test site at the Aquatest/Geotechnika technical site in Nučice. Based on the test experience, a 15 mm-diameter, 28 cm-long GGL probe (Fig. 4) with a gamma-ray detector based on the SBM-21 miniature Geiger–Müller tube

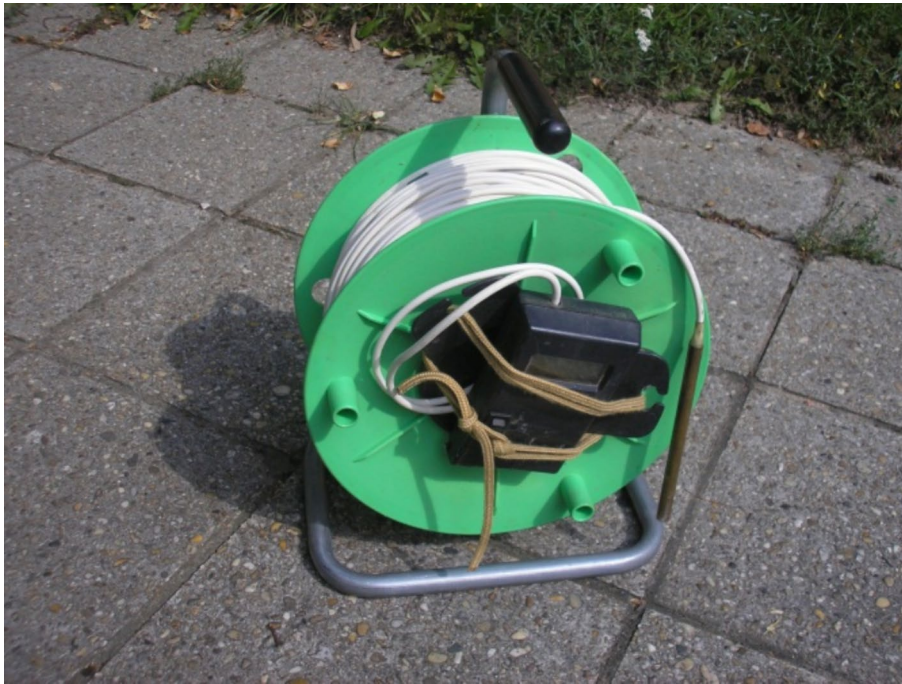
Fig. 5 Ground heat exchanger pipe thermometer

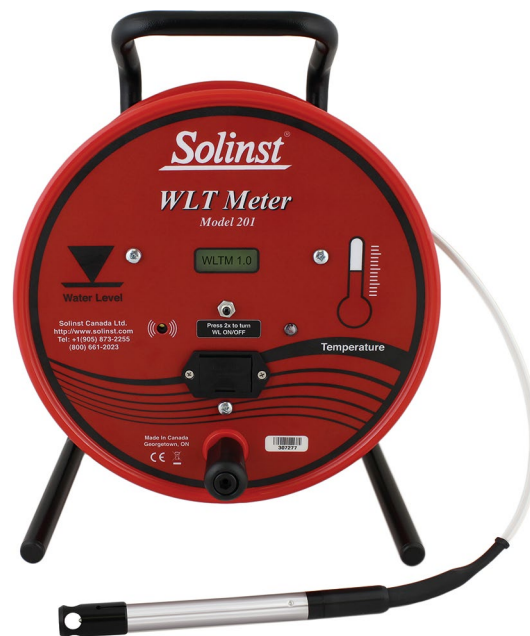
Fig. 6 Level gauge with thermal sensor

for satellite instruments under the Interkosmos program. With resistances in the kilo-ohm range, the sensors have linear characteristics over the applicable temperature range (0–40 °C) and low-temperature noise. The sensor itself was watertight and housed in an 8 mm-diameter brass tube with a length of 100 mm, among other things, forming the necessary ballast for embedding in the pipe. The thermometer was approximately set to measure between 0 and 40 °C using a calibrated thermometer with a division of 0.1 °C. However, developing new thermometers to measure the temperature in borehole exchangers for heat pumps is unnecessary. Suitable commercially available thermometers with an accuracy of tenths to hundredths of degrees Celsius are included in some probes for measuring water levels in boreholes. The diameter of these probes was less than 16 mm (Fig. 6).

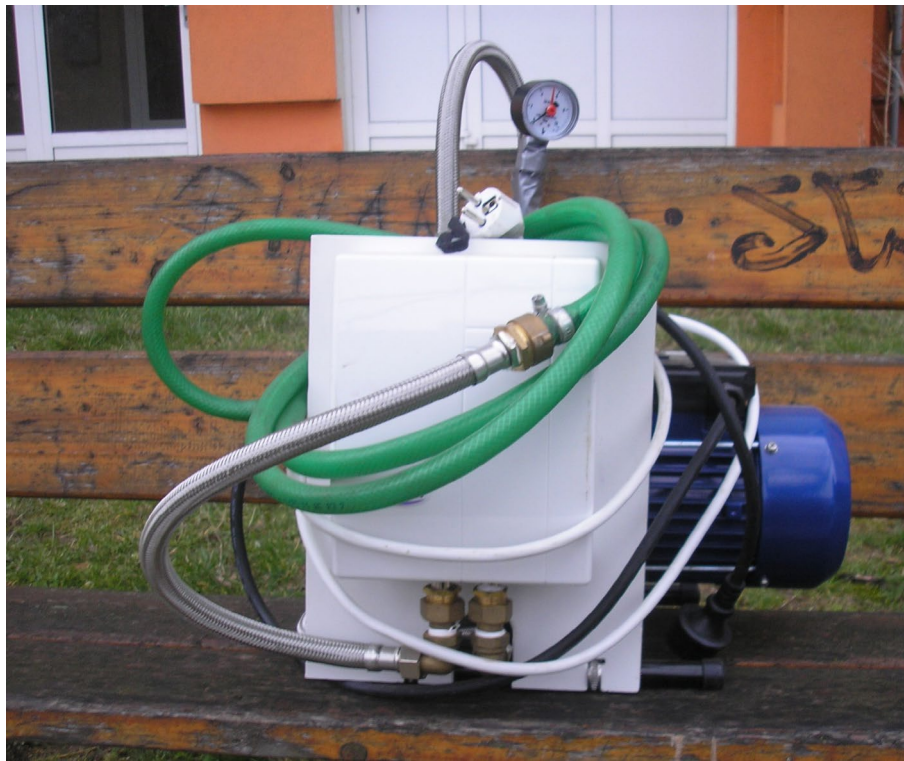
Fig. 7 Induction thermometry device with a heat output of 3 KW

The idea was implemented in a device with a thermal capacity of 3 KW (derived from a maximum current of 16 A in a 250 V socket). The core of the device was a commercially sold direct heating system with an input of ~ 3 KW (<https://www.dzd.cz/en>). A self-priming circulating pump with a discharge capacity of ~ 1 l/s and a maximum discharge height of 42 m was used to circulate the water in the ground heat exchanger. The system (Fig. 7) was able to heat the rock mass in the vicinity of the borehole from ~ 8 – 25 °C in an hour under the conditions of the eastern and western parts of the Bohemian Cretaceous Basin.

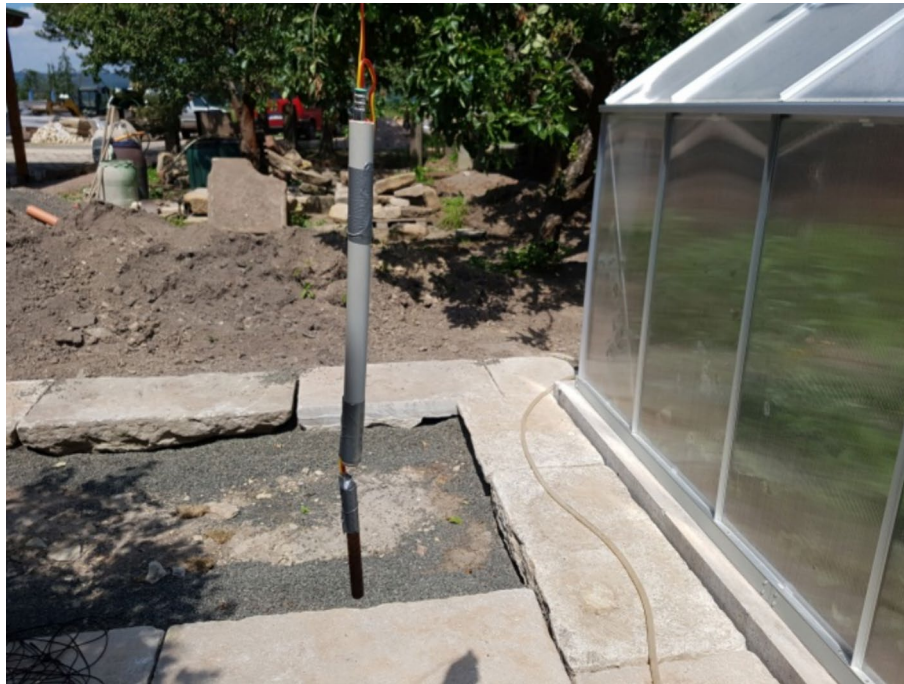
Fig. 8 Semtex charge design

In 2018, experimental blasting of plastic pipes took place on the premises of Explosia a.s. Based on these experiments, Semtex (<https://explosia.cz/app/uploads/2017/11/Explosives-catalog-2017.pdf>) plastic blasting charges were developed to enable safe blasting work in the pipes of earth exchangers in the intramural areas of municipalities. Semtex explosive was used because of its high detonation velocity (7 km/s) and small detonation diameter (5 mm). The developed charge, weighing 150 g to 200 g, is equipped with a weight for easy insertion into the exchanger pipe (Fig. 8) and a device to reliably cut the wire for detonation (principle of the Stringer anti-aircraft missile warhead). The problem with such a developed charge is that it requires approval for blasting in the Czech Republic (Act ČR No. 61/1988 Coll 2024). It takes about a year to process the approval. Currently, experiments are underway using the Pyrotechnic compositions that are used in fireworks (Fig. 9). The construction of the Pyrotechnic charge is similar to that of the Semtex charge. Due to the different physical actions of the Semtex and Pyrotechnic compositions, the need to cut the wire to detonate the explosive is eliminated.

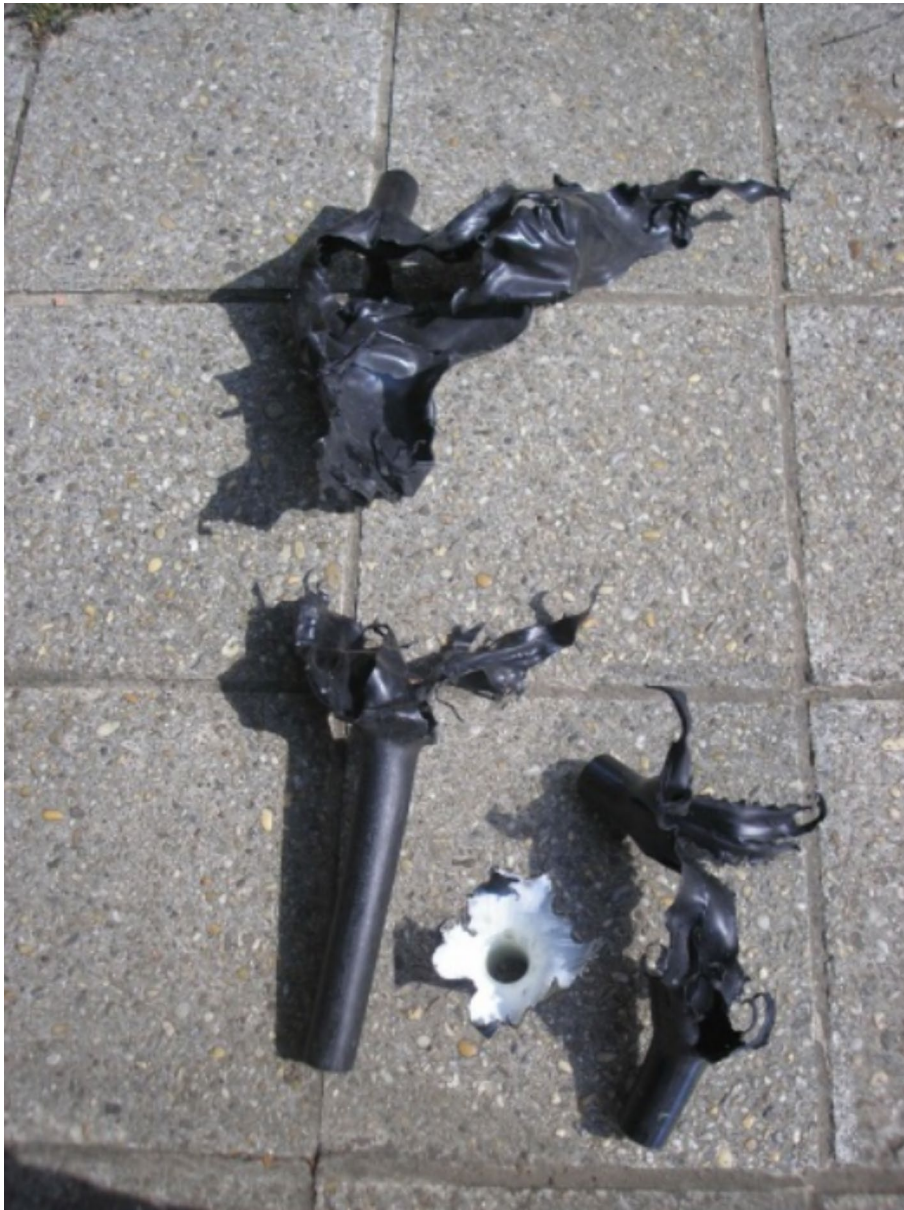
Fig. 9 Experimentally ruptured PE pipe, left from the Semtex charge, right from the pyrotechnic charge

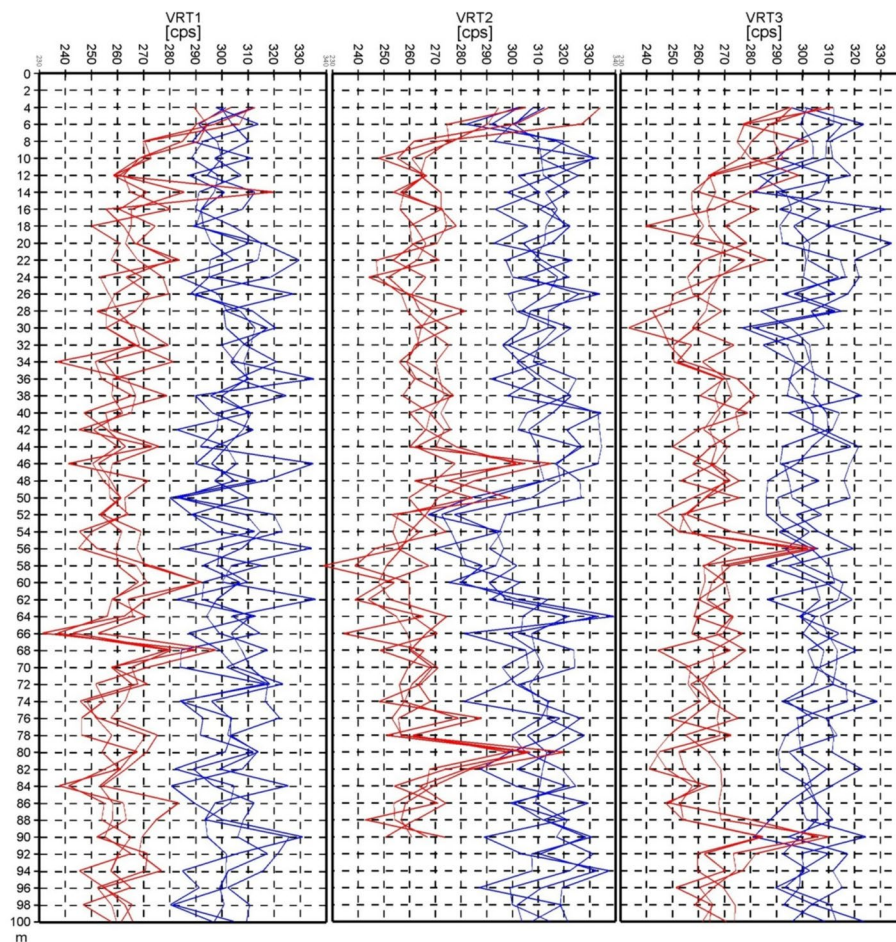
Fig. 10 Measurement results of the GGL from selected boreholes near Nebřenice (a village near Prague). The blue lines denote measurements in four pipes before grouting; the red lines denote measurements in the same pipes after grouting. Values less than 270–280 counts/s can be regarded as areas with high-quality grouting, and values greater than 290–300 counts/s correspond to nongrouted areas. In borehole 2, at depths ranging from 44 to 52 m, a fallen drilling crumbling (52–60 m) and a tectonic fracture noticeably affected the cavern. Measurements in borehole 3 indicated an interrupted column of the grouting material at 56 m and 90 m depth. This phenomenon has also been observed in other boreholes

A small-diameter GGL probe was used to measure all four heat exchanger pipes. The drilling company's management argued that the measurement of the density of the grout in the heat exchanger pipes did not prove the flow of water through the borehole. Thus, the natural thermal gradient of the ground was also measured at the borehole. After the natural gradient measurement, the mass was heated by an induced thermometry apparatus ("Induced thermometry") to ~ 15 °C. This temperature difference was sufficient to verify that water flow occurred in the borehole outside the heat exchanger tubes in

the nongrouted part of the borehole. The measurements were already conclusive and showed that the borehole was not sufficiently grouted. The measurements, together with the lithology, are shown in Fig. 12. Figure 12 shows that water flows through the borehole (water from the first fractured aquifer flows outside the pipes) at depths ranging from 28 to 36 m (the water level in the borehole is ~ 36 m) and seeps into the fractured aquifer at intervals ranging from 36 m to ~ 50 m. The presented measurements were verified during borehole rehabilitation.

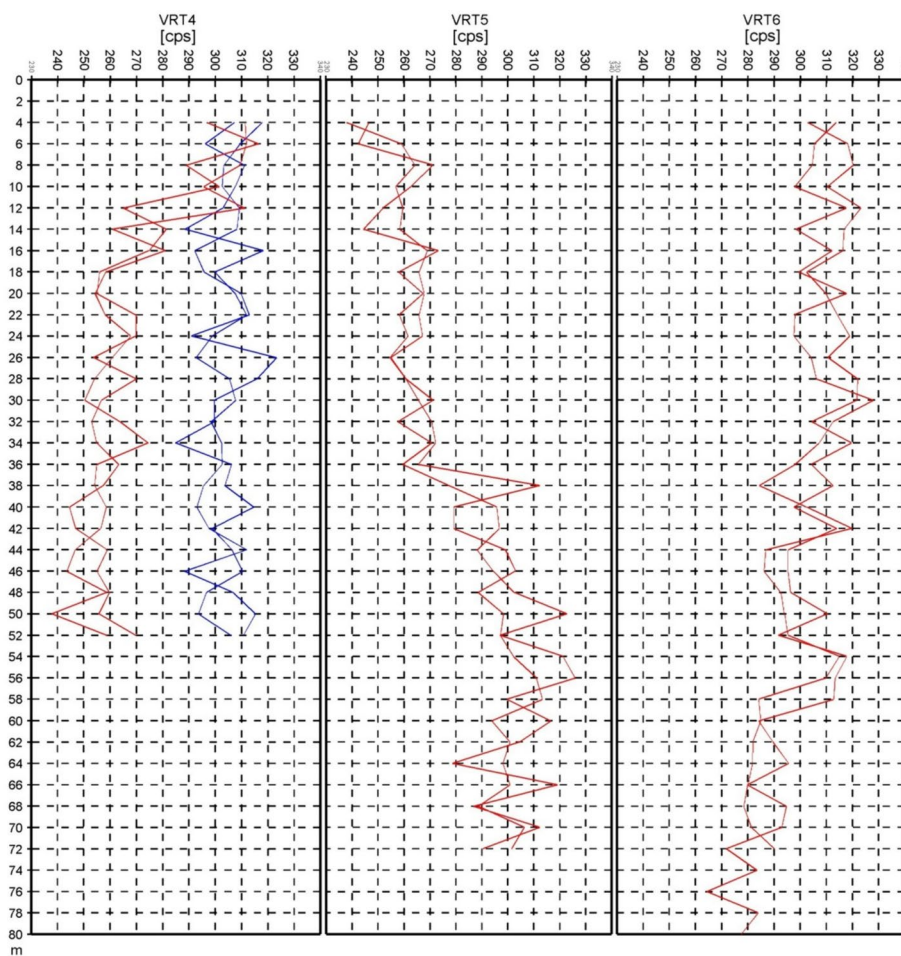
Fig. 11 Measurement results of the GGL at a location near Prague (Nebřenice) from not selected 100 m deep boreholes (behind the builders' backs). The blue lines denote measurements before grouting; the red lines denote measurements in the same pipes after grouting. Values less than 270–280 counts/s can be regarded as areas with high-quality grouting, and values greater than 290–300 counts/s correspond to nongrouted areas. Like boreholes 1–3, borehole 4 also exhibited problems with grouting down to a depth of ~ 14 m. Borehole 6 was not grouted down to a depth of ~ 60 m, while borehole 5 was missing grouting from 38 m below

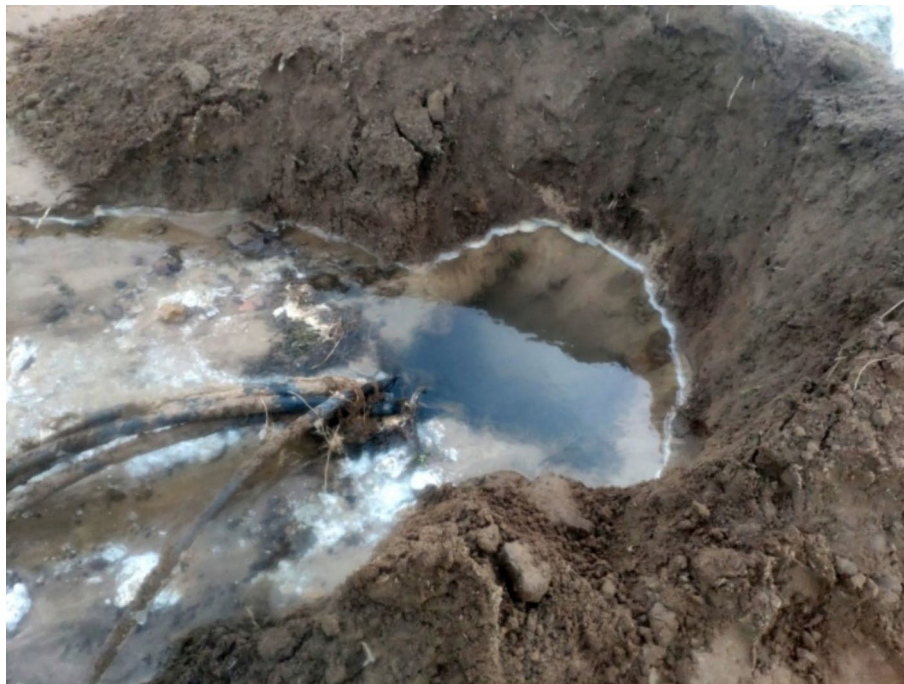
Fig. 13 Overflow of ~ 3 l/s in the village of Černěves

Methods for measuring ground heat exchangers were used in June 2022 to detect water intrusion through two overflowing boreholes into Quaternary sediments in the village of Černěves. The first borehole did not show any signs of anomalous behavior; however, at the second borehole, an overflow of ~ 3 l/s was observed between the exchanger tubes (Figs. 13, 14). The natural thermal gradient measurement method was used first (Fig. 15). It was already apparent from the results of these

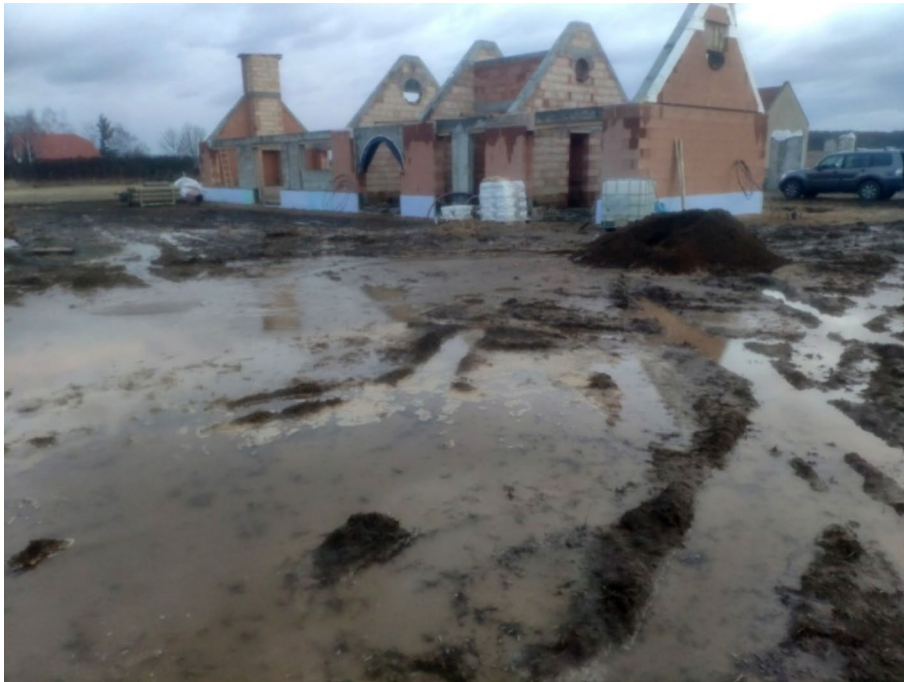
Fig. 14 Consequences of groundwater overflow

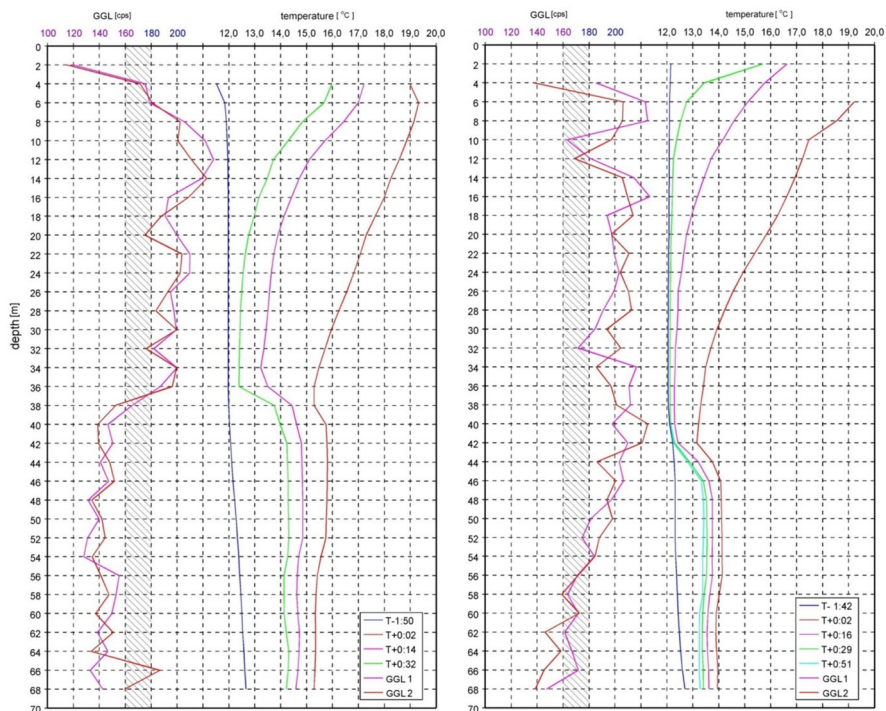
Fig. 15 Measurement results in June 2022; the left panel shows the borehole CSN, and the right panel shows the borehole CST (see Figs. 13, 14)

The method of induced thermometry at the Černěves location confirmed the first thoughts about defectively injected wells (Fig. 15). Vertical movement of water toward the surface can be observed in the curves of the CSN and CST boreholes. The results of the temperature measurements were also confirmed by the gamma–gamma well-logging method, where two opposite pipes of the ground exchanger were measured (GGL1 and GGL2; the hatched area indicates the area of uncertainty in the method used, i.e., the area where it cannot be determined whether the borehole is well grouted). The CSN borehole was injected only to a depth of 36 m. In the CST borehole, grouting was confirmed only below a depth of 60 m. In the depth interval from 44 to 60 m, there was a filling of rocks (probably gravel-sand) in the borehole.

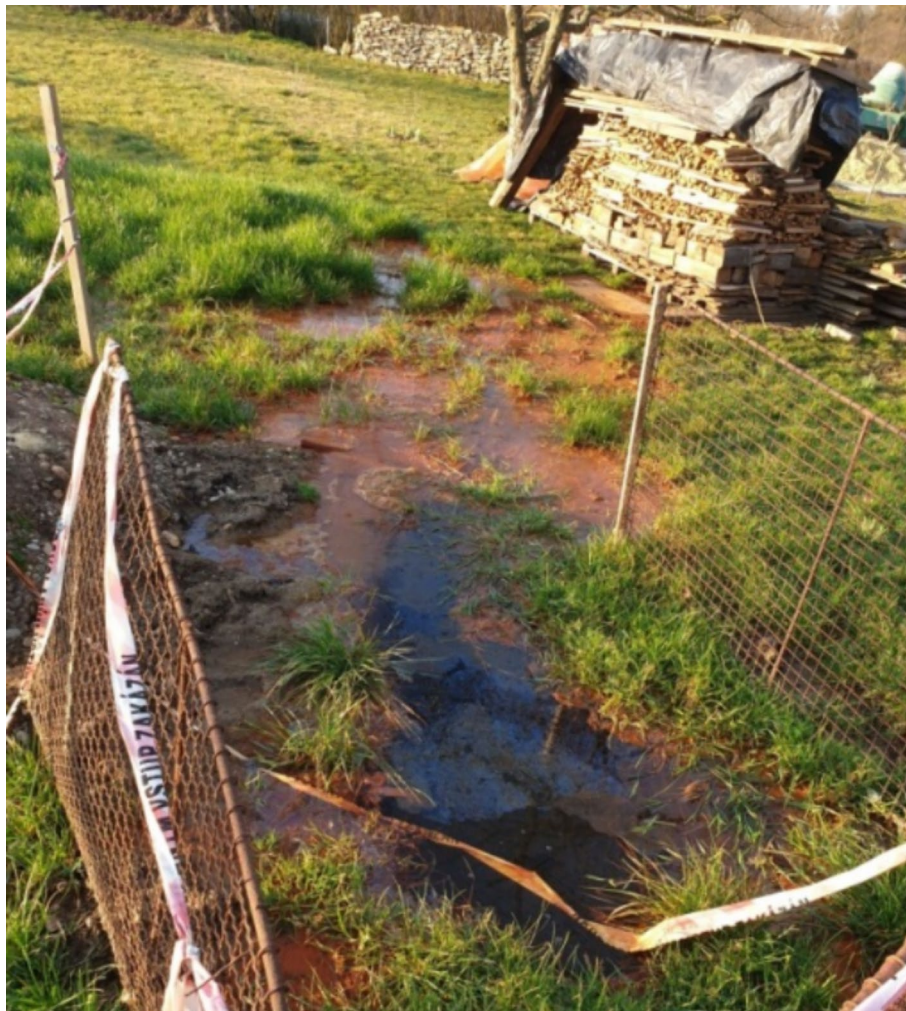
Fig. 16 Overflow of ~ 2 l/s in the village of Louny

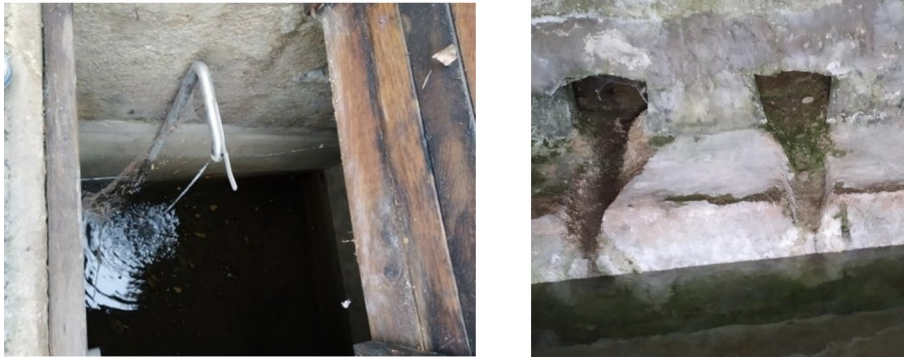
Fig. 20 Spring overflow in the village and water in the second spring on 24 October 2019

October 2019 (one perforated exchanger pipe was used to monitor groundwater levels). On 23.10.2019, the residents of the surrounding area registered the onset of water levels in their wells, and a day later, the exploited spring overflows in the village were recovered (Fig. 20).

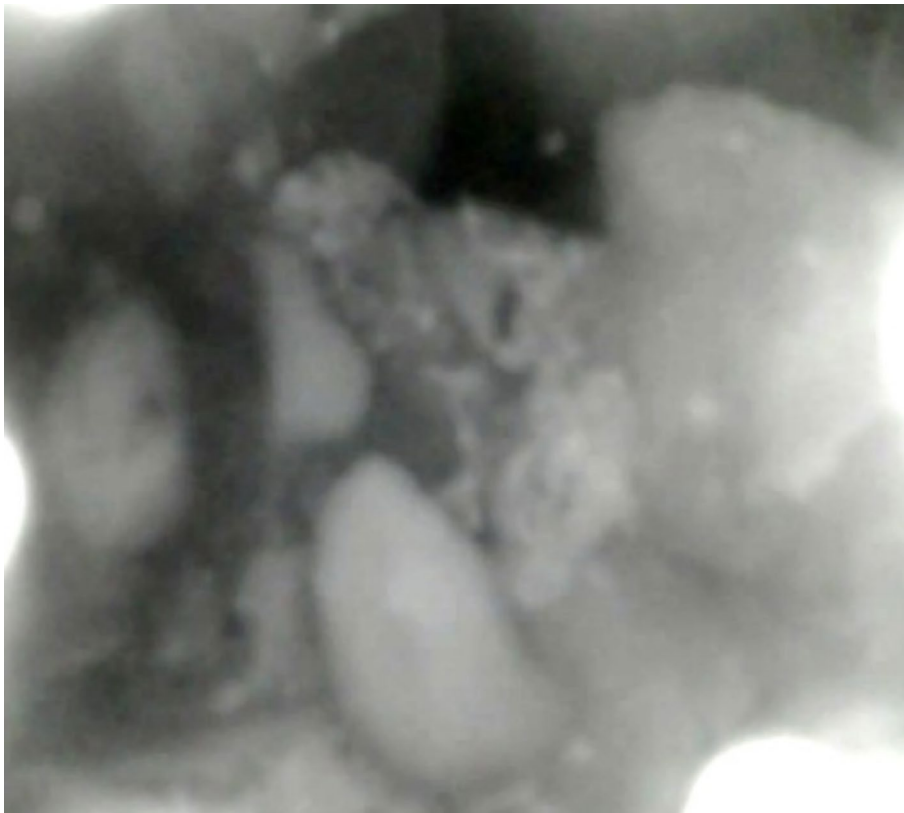
Fig. 21 Area of the hole (up) in the pipe of the ground heat exchanger (inner diameter 25 mm) at a depth of 40 m

A similar procedure was adopted for the Černěves site. One pipe of the ground exchangers was perforated at a depth of 34 m (borehole CSN) and at a depth of 40 m (borehole CST) with a body containing 10 g of pyrotechnic composition (Fig. 21). The

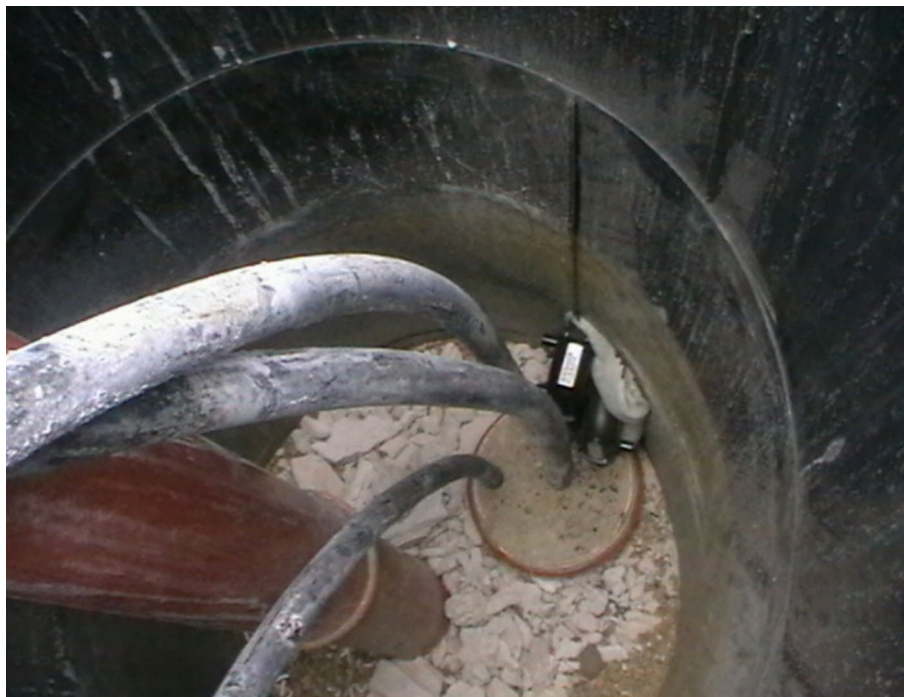
Fig. 22 Cerneves site July 2023. Top right: inlet to the technology (see Figs. 13, 14)

second pair of pipes was left unperforated, in contrast to the procedure at the village of Kuks. After grouting 1.5 m³ (well CSN) and 2.2 m³ (well CST) with concrete, the overflow from the intercepted aquifer stopped. In the case of the CST borehole, overflow was visible immediately after the remediation intervention, while in the CSN well, it was verified acoustically (Figs. 18, 19). After overflow remediation, pressure tests were successfully applied to the remaining pairs of nongrouted ground exchanger tubes. After the pressure tests, the ground exchangers were connected to the heat pump (Fig. 22).
